# Manhole Inspection Summary

Manhole # S51A\_\_035MH

Insp Date: **5/6/08 10:17 AM**

**Location** Address: **rear 411 n kenwood ave**

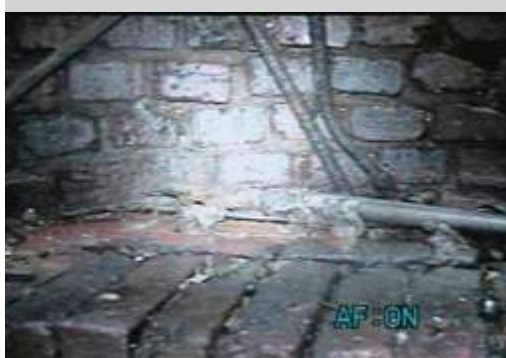
Misc

bench debris

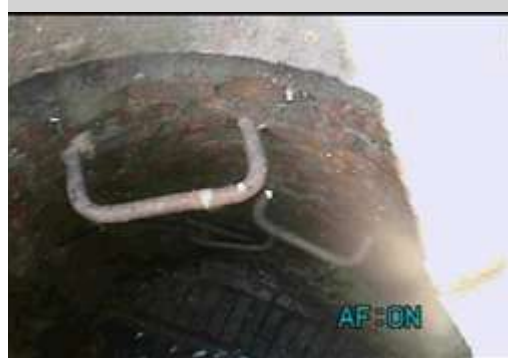
Defect 2

**Steps** Count: **3** Missing: **0** ☒ **Corroded**

corroded steps

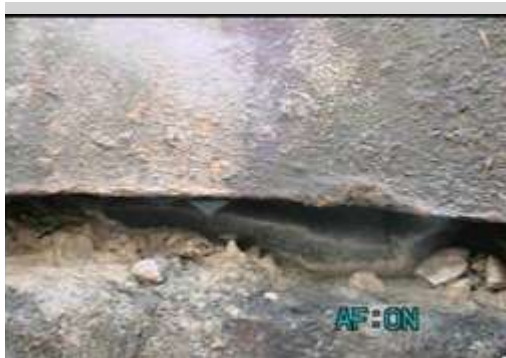
Defect 1

Condition: ☐ Sound ☐ Cracked ☐ Root Intrusion ☐ Loose Brick ☒ **Deteriorated**

loose bricks, deteriorated chimney, frame adjustment

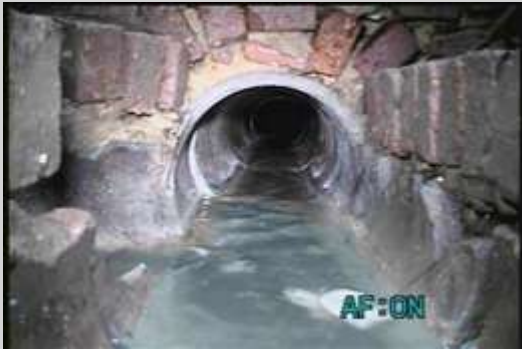
12 O'Clock Outflow

10 in. Circular Gravity Sewer  
Pipe Out @ 12 O'Clock

Invert Depth: 7.91 (ft.) Flow Characteristics: **Fast**

Infiltration: **None** Pipe Seal Cond: **Unknown**

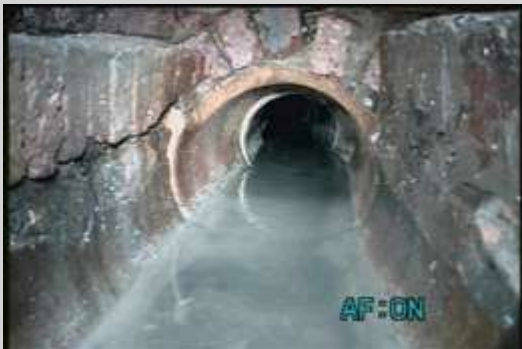
6 O'Clock Inflow

10 in. Circular Gravity Sewer  
Pipe In @ 6 O'Clock

Invert Depth: 7.84 (ft.) Flow Characteristics: **Fast**

Infiltration: **None** Pipe Seal Cond: **Unknown**

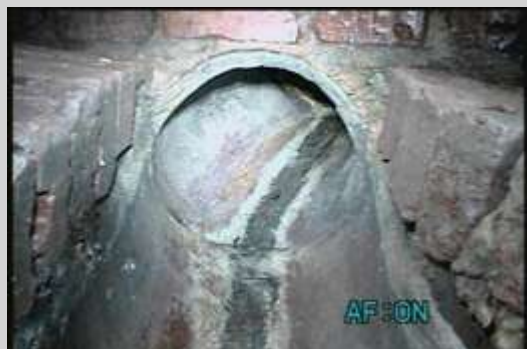
9 O'Clock Inflow

8 in. Circular Gravity Sewer

Pipe In @ 9 O'Clock

Invert Depth: **7.67** (ft.) Flow Characteristics: **Slow**

Connects To: **Dead End**
